**Key words:** RW reservoir, taste and odor, blue-green algae

**Reservoir or Lake Use:** Reservoir # 2 is a raw water storage reservoir for the city, and was built for additional storage for drinking water.

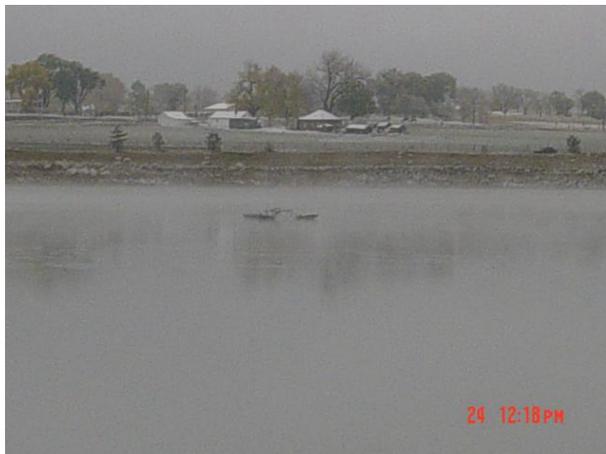
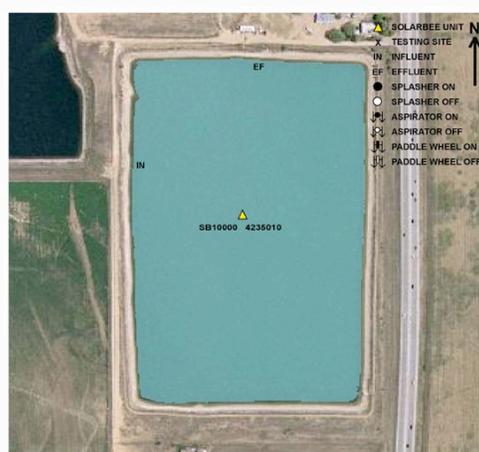
**Photos:** Shows one unit in the reservoir; aerial photo shows reservoir shape and location of initial SolarBee installation.

**SolarBee Installation:** Date: October 2002, installed one (1) SB10000F, solar-powered, with intake hose set at 23'. February 2004, installed a second SB10000F in the reservoir.

**Results:** Within one day after installation the customer could see the entire surface moving. By January 2003, the water quality had sufficiently improved that the city could double the use of water from this reservoir. Water quality remained good throughout 2003 without blue-green algae blooms. Nevertheless, the customer decided to add a second SB10000F that was installed in February 2004. The reservoir manager reported that 2004 and 2005 were good years without either blue-green algae blooms or taste and odor issues, and is very satisfied with the performance of the SolarBees in the reservoir. The city is now able to use the entire reservoir volume for drinking water purposes. In October 2005, the city's Public Works Department received an award from the Colorado Environmental Leadership Program for their successful use of "green" technologies to resolve their lake management problems.
